Best Practices in Evaluation and Restoration of Degraded Mediterranean Environments

3.1. Study case 1: Restoration of Pobra do Caramiñal saltmarsh (NW Iberian península)

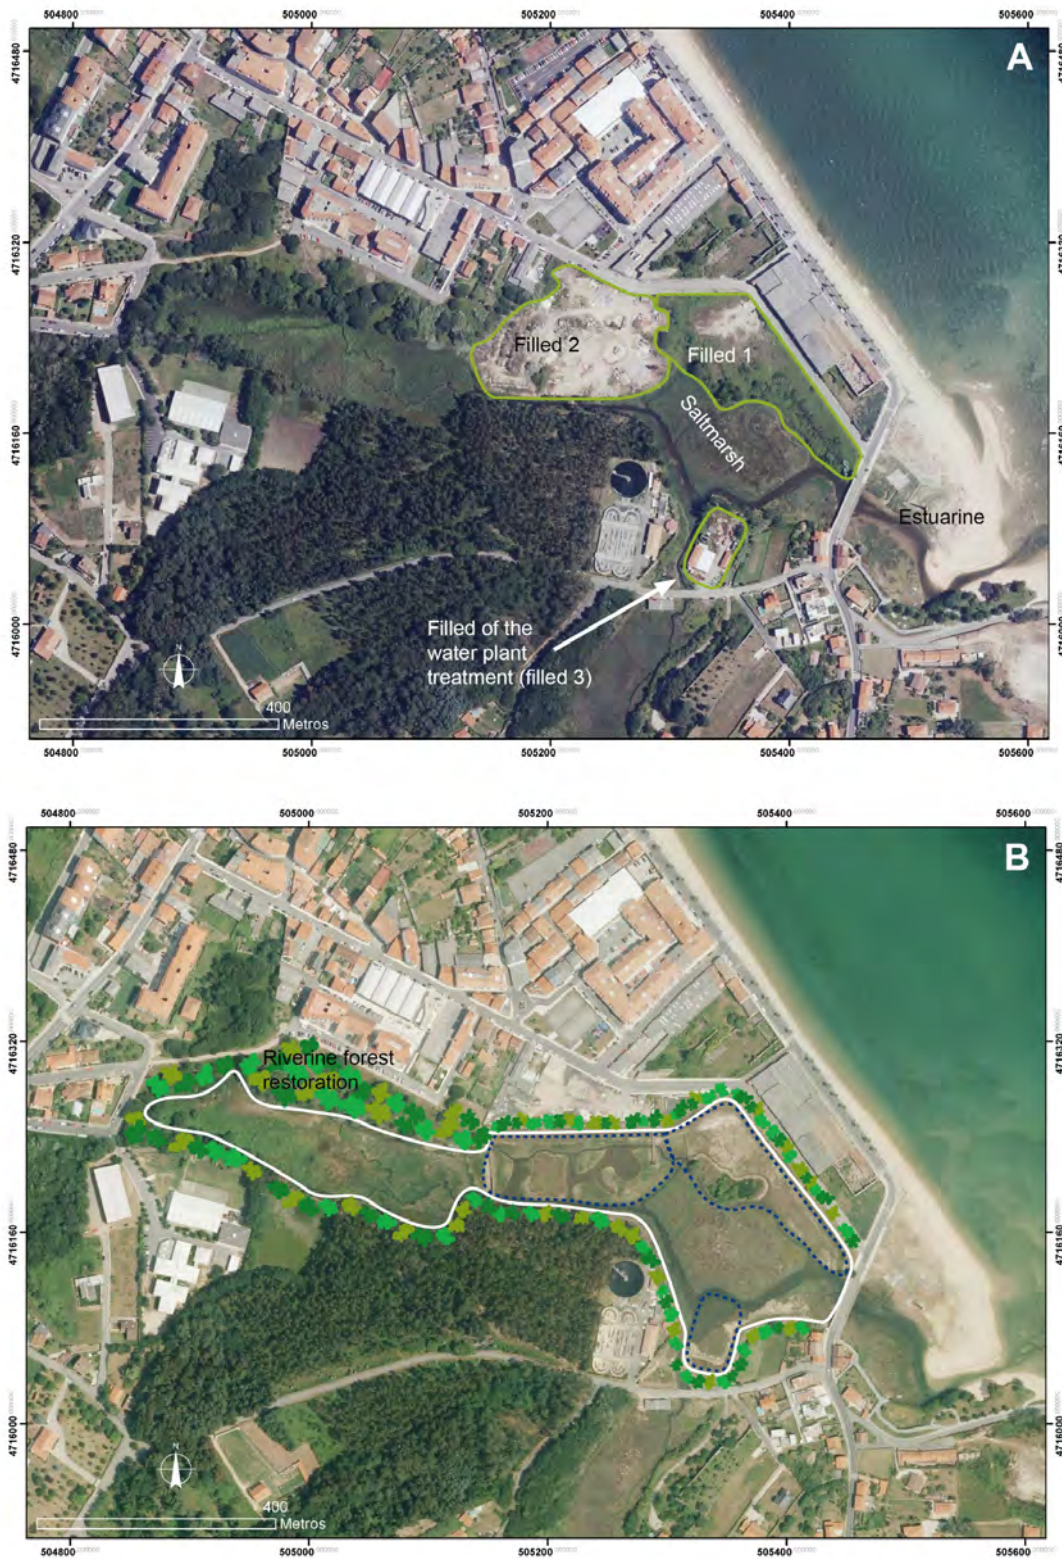
Figure 1. Aerial view of the Pobra do Caramiñal saltmarsh in 2014 (A), before the start of the interventions, and in 2017 (B), after the interventions. In the 2014 aerial photograph, sections (1), (2), and (3) indicate areas where fillings occupying more than 50% of the saltmarsh area were removed. Section (4) corresponds to the area where invasive species were removed and channels and riparian forests were restored. In the 2017 aerial photograph, sections (1), (2), and (3) correspond to newly restored saltmarsh areas.

Alterations were first assessed by photographic interpretation of a 1954 flight in which the saltmarsh showed an acceptable conservation status. Subsequent aerial photographs (years 1968, 1976, etc.) showed that a significant portion of the area was already occupied, both for the construction of public infrastructures (roads and a water treatment plant) and for privately owned filled areas under irregular concessions. Occupied areas represented more than 50% of the saltmarsh complex in 1999, mostly corresponding to a private filled area (Figure 1).

Recovery and restoration of the saltmarsh area was the main action within the project. Using aerial photographs from 1954 as a reference, it was determined that 50% of its initial area was occupied by filled areas of different nature. The inner portion and banks of the saltmarsh (approximately 10%) were urbanized and were therefore impossible to restore. Recovery of the saltmarsh area focused on areas used for storage of materials or occupied by an old water treatment plant built in the wetland area. The area covered by these filled areas was approximately 4 Ha, and the filling was between 1 and 4 m thick. Total recovery of the saltmarsh involved the extraction of large volumes of filling material and its transportation to an authorized dumping site. Taking into account the peri-urban nature of the saltmarsh, the decision was made to remove only the filled areas in the center of the saltmarsh and part of the ones on the banks, which represented approximately a 50% increase in the saltmarsh area. The remaining filled area was transformed into an island that served as refuge and breeding area for Anatidae species, and riparian forest species were replanted along saltmarsh banks with the aim of generating a green barrier. Consequently, there was a 50% increase in shrub area as well.

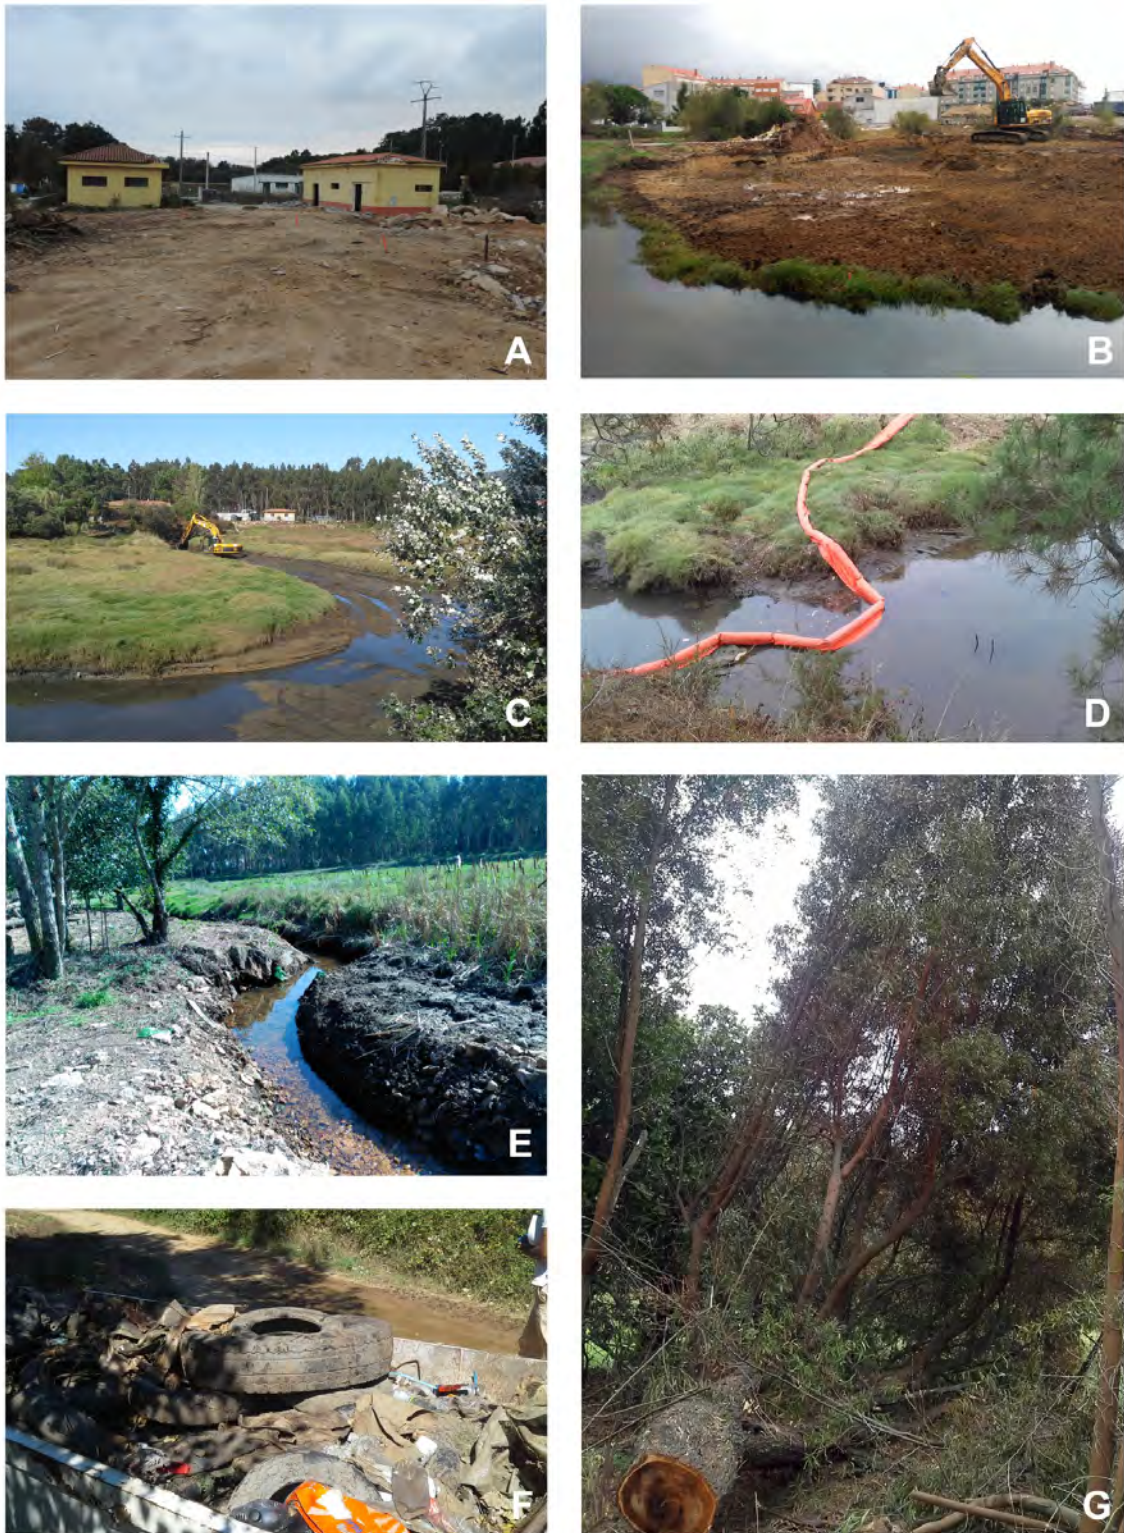
Figure 2. Summary of activities carried out for the restoration of the environmental quality of the Pobra do Caramiñal saltmarsh. A) Overview of the old wastewater treatment plant built in the saltmarsh (filled area 3; Figure 1). This plant was removed and part of the saltmarsh was restored (Figure 1 B); B) Removal of filled area 2 (Figure 1); C) Dredging of polluted sediment; D) Protection barriers for containing suspended materials during sediment dredging; E) Hydrological restoration. Recovery of secondary channels within the saltmarsh; F) Removal of urban solid waste; G) Removal of invasive plant species and restoration of the riparian forest.

Additionally, wastewater discharges, presence of invasive species (*Acacia melanoxylon*, *Arundo donax*, *Cortaderia selloana*), riparian forest degradation, and strong alterations of the hydrologic system are also worth mentioning (Figure 2).

The first intervention corresponded to the removal of invasive species occupying a large portion of the saltmarsh banks, as well as of waste of diverse origins. The main species removed were *Acacia melanoxylon*, *Eucalyptus globulus*, *Arundo donax*, and *Cortaderia seollana*, and the riparian forest was restored by planting the main species that characterize this habitat: *Alnus glutinosa*, *Salix atrocinerea*, *Fraxinus angustifolia*, *Quercus robur*, *Corylus avellana*, and *Sambucus nigra*. Additionally, microhabitats within riparian forest areas (specifically small temporary pools, important for reproduction of amphibians) were restored (Figure 2).

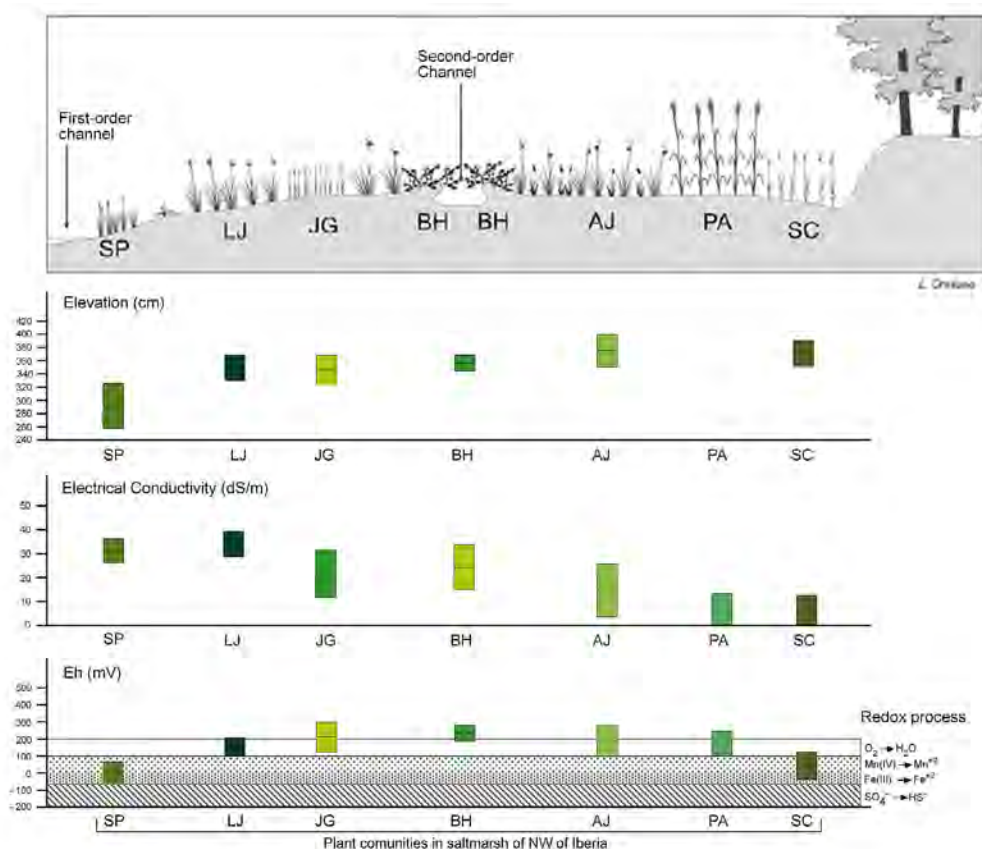
Figure 3. Schematic profile of the NW Iberian Peninsula saltmarshes. SP: *Spartinetum maritimae*: this community is the only one able to colonize saline, highly reduced substrates with high hydrogen sulfide concentrations in interstitial water. LJ, JG, AJ: *Juncus maritimus* communities: LJ: *Limonio-Juncetum maritimae* subass. *typicum*; JG: *Limonio-Juncetum maritimae* subass. *Juncetosum gerardi*, AJ: *Agrostio-Juncetum maritimae*. Reed beds occupy most of the higher saltmarsh, with soils that present suboxic oxidation-reduction surface conditions. The three formations are distributed within the saltmarsh according to salinity: LJ occupies the most saline environments (electric conductivity: 30-40 dS/m), while AJ occupies the least saline ones (electric conductivity: 10-25 dS/m). BH: *Bostrychio-Halimionetum portulacoidis*. This community appears mainly on soils with oxic surface conditions and is therefore closely associated with saltmarsh channel banks, where tidal flooding periods are short and aeration is favoured by the channel. When soils are sandy, it can expand towards the inner part of the saltmarsh. It tolerates wide variations in electric conductivity, while redox potential must be over 300 mV. SC: *Scirpetum compacti*. This community occupies saltmarsh banks connected to continental areas, which show strongly reduced conditions with high sulfide concentrations but, unlike in the case of *Spartina maritima*, flooding water must be either fresh or brackish water. PA: *Phragmitetum australis* community. Reed beds are also associated with saltmarsh banks flooded by circulating freshwater; therefore, redox.

mainly from rivers, as well as variations in oxidation-reduction conditions (redox processes). Prolonged flooding leads to soil reduction. Depending on the intensity of reduction, soils can show suboxic or anoxic conditions. Suboxic conditions entail the dissolution of Fe and Mn oxides and hydroxides, releasing their reduced soluble forms (Fe^{2+} y Mn^{2+}) into interstitial water; these forms are phytotoxic, mainly for dicotyledonous species such as *Halimione portulacoides* (Figure 3). However, in permanently flooded soils, surface conditions are already anoxic, characterized by the reduction of sulfate ion to hydrogen sulfide (H_2S), which is highly phytotoxic for most saltmarsh species except for *Spartina maritima*. The ability to endure salinity and phytotoxicity of reduced forms determines the distribution of communities within the saltmarsh. Figure 3 shows the geochemical conditions that characterize each one of the main plant communities in Galician saltmarshes.
